Failure analysis of high temperature superheater tube (HTS) of a pulverized coal-fired power station

Md. Mujibur Rahman, Ahmad Kamal Kadir

Abstract- This paper presents the failure investigation of high temperature superheater (HTS) tubes. Samples were collected from one of the coal fired power plants in Malaysia, namely, Stesen Janakuasa Sultan Azlan Shah, Manjung (Manjung Power Station). After eight years of non-continuous services of three boilers, welded support-clips were completely separated (detached) from (HTS) tubes, which caused the wall thinning. Collected failed samples were undergone several experimental investigations including visual inspection, thickness measurement, Vickers hardness testing, and microstructure evaluation. The results revealed that some cracks were initiated at the heat-affected zone (HAZ) and propagated partly throughout the weld metal. The estimation on operating temperature and operating hoop stress show indication that the specimen may experienced a high operating temperature. Other findings confirmed that the detachment of welded support-clips from HTS tubes may also caused by dissimilar metal weld (DMW) failure due to the differences in expa

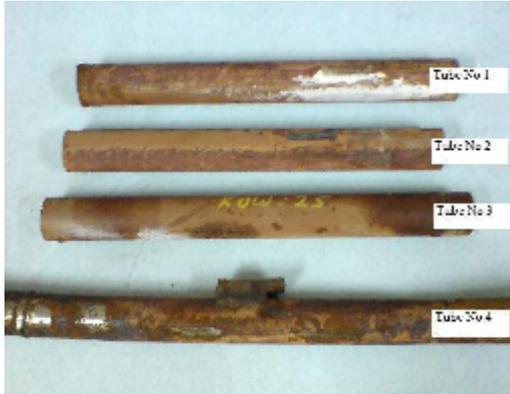
Four samples of failed HTS tubes from coal fired boiler unit 3 were collected. The as-received failed HST tubes are shown in Fig. 1. Visual inspection, dimensional measurement, non-destructive testing, hardness measurement, and microstructure evaluation were conducted to analyze the failure of the collected high temperature superheater (HTS) tubes.

Fig. 1 The as-received failed high temperature superheater (HTS) tubes

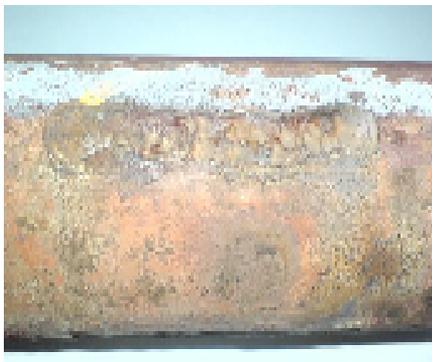
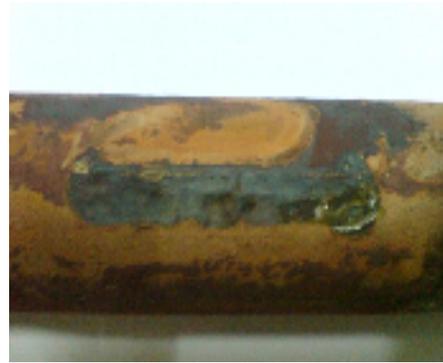
Visual inspection revealed that all examined HTS tubes were found to be suffered from thinning problem located where the surfaces are welded to clips, supports or brackets as shown in Fig. 2. Ferritic material has completely separated leaving the weld zone and parts of the parent metal of HTS are detached together with the welded metal. The evidence of corrosion pitting is found in a distinct band on the outer surface of the tube (Fig. 3). Corrosion deposits are present throughout the pit defects, with most of the pits having an oxide crust. The tube corrosion pitting is likely a result of oxygen corrosion, resulting from oxygenated water in contact with the tube surfaces.

Fig. 2 Close view of failed HTS tubes

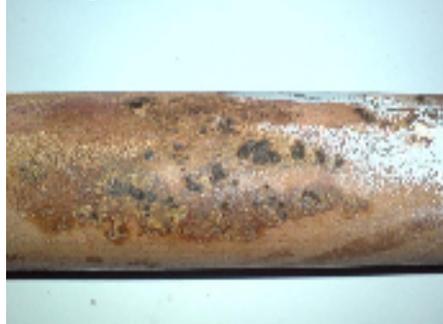
Fig. 3 As-received tube showing the tube pitting corrosion

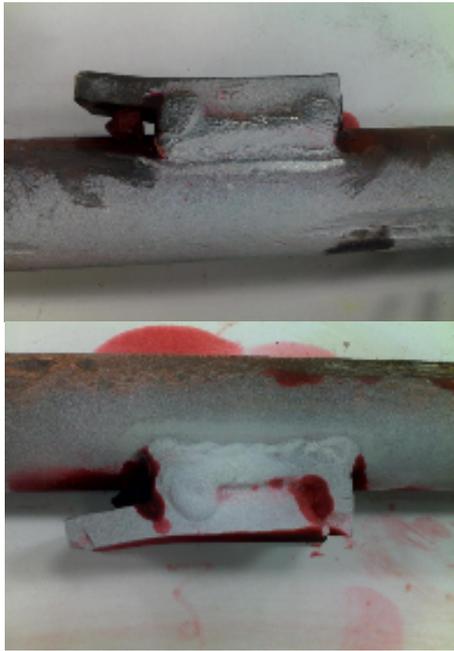
However, the results of liquid penetration testing did not indicate the occurrence of any crack across the external surface of welded location (Fig. 4). Measurement of the remaining wall thickness on the damaged zone of the tube was conducted on tube no 1 and tube no 2 through ultrasonic thickness test measurement (UTTM). The measurements of wall thickness of the tube surrounding the damaged zone from three different locations along the tube were also conducted. The minimum remaining wall thickness at the damaged zone of HTS tubes and wall thickness at non-damaged zone along the HTS tubes are shown in Table 4 and Table 5, respectively.

Fig. 4 Developer is applied for defect indication

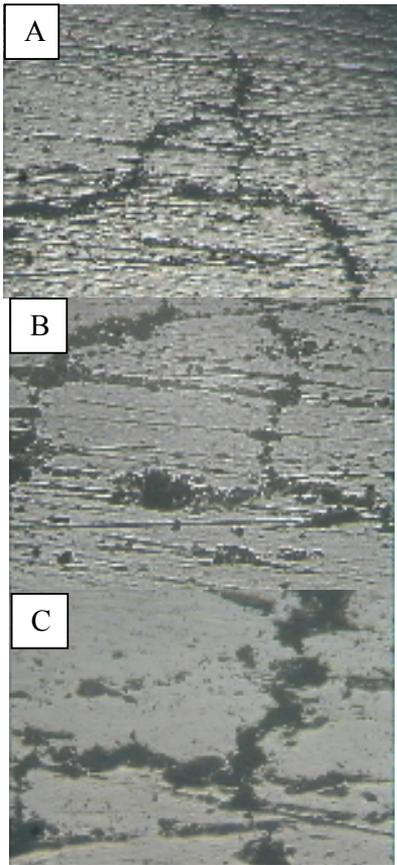
Sample from tube no 4 was prepared and subjected to microscopic examination. Fine cracks are observed on the weld metal surface located adjacent to the heat affected zone (Fig. 5). General view of the fracture morphology on the weld metal of the failed HTS tube was brittle. However, the observed fine cracks were originated from the high stressed HAZ and propagated partly throughout the weld metal (Fig. 6). It is suspected that the cracks were grown during the operations of the tube, particularly the action of shutdown and start-up assisted the crack propagation. In order to establish the crack path and confirm the finding that the HTS tube are failed as a result of dissimilar metal weld (DMW) failure, detailed metallographic examinations have been conducted. Fig. 7 shows that the failure tends to be catastrophic where the tube was failed across the heat affected zone of the weld section of HTS tube.

Fig. 5 Photomicrographs of surface crack zone on weld metal: (A) 4 x 0.1 zoom, (B) 10 x 0.25 zoom, (C) 20 x 0.4 zoom

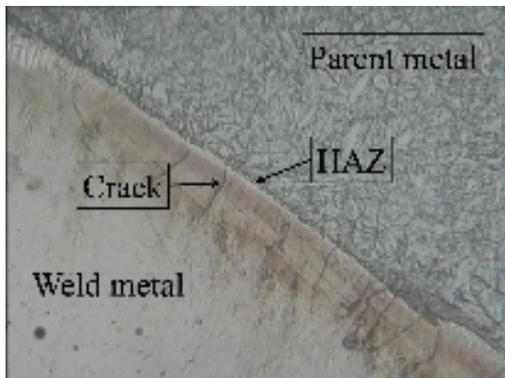
Fig. 6 Metallographic view of the propagated cracks on the failed zone on HTS tube (20 x 0.4 Zoom)

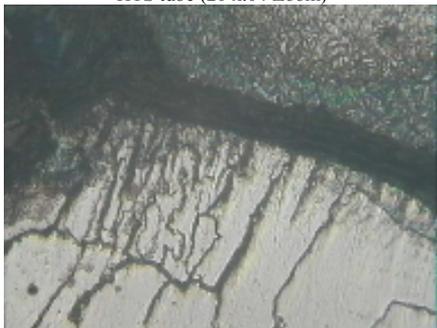
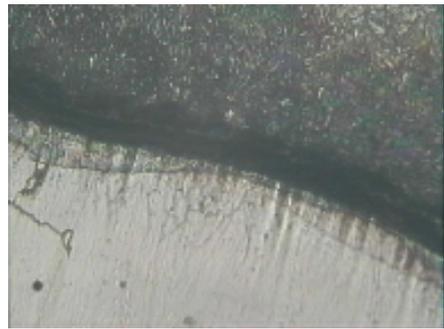
Fig. 7 Photomicrograph showing DMW creep voids at ferritic interface

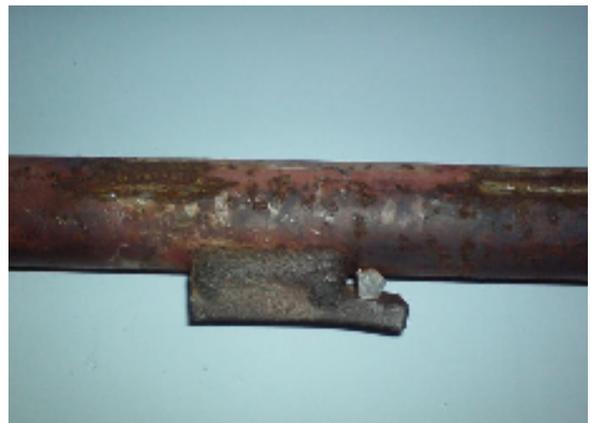
The welding joints between the tube and clip (Fig. 8) are original welding by the boiler manufacturer in order to hold these tubes in certain position. During the outage inspection, the tube was found detached from clips, supports or/and brackets and the surface of the tube was detached together with the welded metal. These caused the reduction of thickness at the welded location of the tubes.

Fig. 8 General view of welding between superheater tube and support-clip

The detachment of the welded clip from the superheater tube might be caused by the brittle cracking in the heat-affected zone (HAZ) of the weld [13]. As the temperature of the fire-side surface of the tube decreased, the condensation of escaping steam became more. The high sulfur coal burning products are deposited on the outer surface of the tubes and as a consequence, pitting corrosion occurred [14-17]. This might be occurred during the extended out-of-service periods such as outages of boiler.

HTS tubes were considered failed and required to be replaced with new tubes due to the safety purposes.
