Structural Performance Investigation of Ship Lift Hoist Pile Structure Exposed to Tropical Marine Environment

Abstract— This paper presents a field investigation and numerical analysis of a ship lift hoist pile structure exposed to the marine environment. This structure is located at Lamong Gulf in East Java Indonesia. This study focused on analyzing the structural performance of the steel pile of the ship lift hoist structure against gravity and seismic load. The field investigation was conducted using several methods such as visual observation, ultrasonic pulse velocity, half-cell potential and ultrasonic thickness to observe the current condition of the structure. Furthermore, a structural analysis was also performed to investigate the performance of the structure before and after the corrosion presented. Based on the field investigation result, it was found that the steel pile of the hoist structure suffers a loss of thickness due to corrosion. The thickness loss of each pile varies from 0 to 1.9 mm. The half-cell potential on the pile cap also shows that the corrosion potential in more than half the hoist pile cap is very high. Furthermore, the structural performance analysis

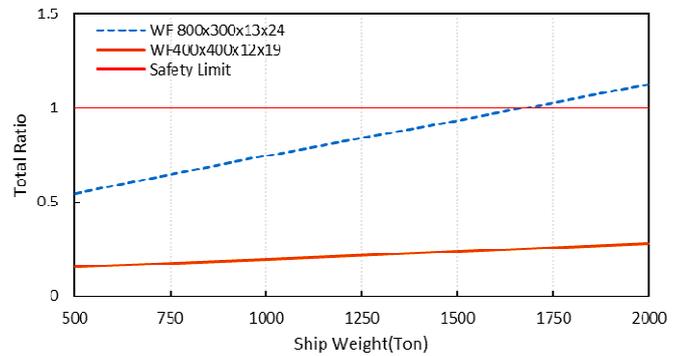
Fig. 6 The demands per capacity ratio of hoist structure against gravity load

The numerical analysis was performed using the SAP 2000. This analysis compared the demand and capacity of the structure against the gravity and seismic load. The hoist structure is concluded to be safe when the resistance ratio of the steel pile is below 1. The demand per capacity ratio more than 1 indicates that the hoist structure is overstressed and cannot withstand the ship load. The load is applied by increasing the ship's weight load gradually from 500 tons to 2000 tons. Fig. 6 shows the result of the numerical modeling of the hoist structure against the gravity load. From Fig. 6, it can be seen that the hoist structure is at a safe limit when receiving a maximum ship load of 1,650 tons. However, over the 1,650 ton of ship weight, the demand per capacity ratio of the WF 800 x 300 x 13 x 24 reaches over 1 and the section becomes overstressed.

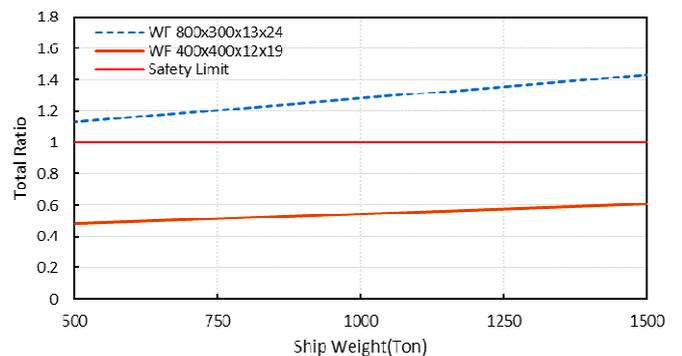
Fig. 7 The demand per capacity ratio of hoist structure against seismic load

In addition to the gravity load, the demand per capacity ratio of the hoist structure is also calculated against seismic load and the result is shown in Fig. 7. Different from Fig. 6, the analysis result shows that the performance of the hoist pile structure has exceeded the safety limit. Even though the WF 400 X 400 X 12 X 19 pile is still in the safe zone, another pile had clearly lost its capacity to withstand the applied load. This condition happened due to the corrosion of the hoist pile. The corrosion on the hoist pile causes the steel pile to loss its thickness of the web and flange which

leads to the section being overstressed and decreases the overall performance level of the pile structure.
