Non-Destructive Testing by Ultrasonic and Thermal Techniques of an Impacted Composite Material

Abstract— The aim of this work is to control the state of the structure of a composite material after low velocity impact. In fact, the impact damage is one of the most critical flaws that can reduce the intrinsic characteristics of a composite structure drastically. The diagnostic of composite laminates in this case will be very difficult, because during impact several modes of failure appear (matrix cracking, delamination and fiber breakage), and it can be often not visible on the surface. For this reason it will be necessary to use the non-destructive techniques (NDT) of control to make sure of the state of the material without damaging it. This paper presents some methods of control to detect and characterize defects appeared after low velocity impact on a hybrid composite plate of epoxy resin reinforced with carbon fiber. The methods used in this work are considered among the most used in the control of composite material. Indeed, each technique has advantages and disadvantages. Therefore, the use of several control techniques ensures the diagnosis, so we talk about the complementar

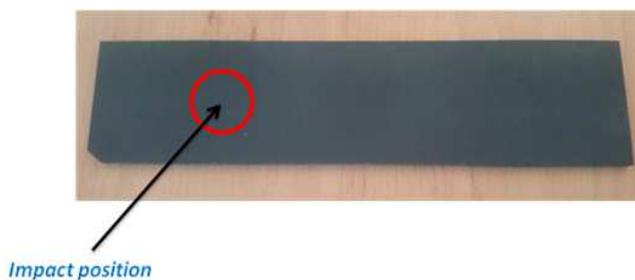
The component is damaged by a low velocity impact event. The impact test is performed manually using a hammer. Noted that, the impact did not penetrate at the bottom of the specimen as present in the figure 2.

Fig. 2 Composite component after low velocity impact.

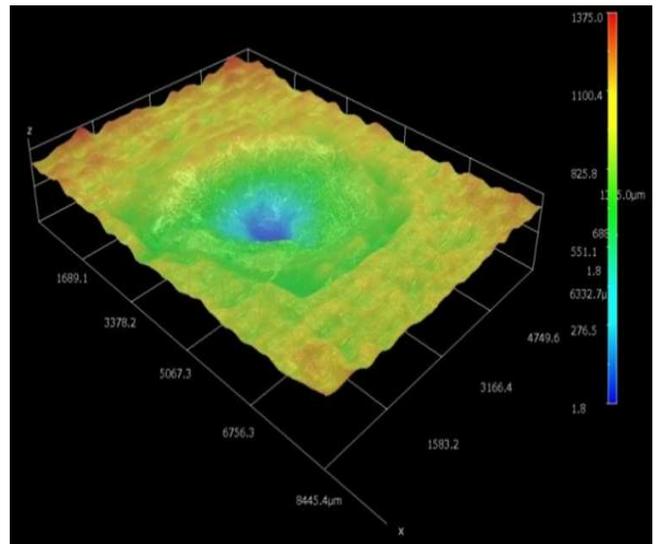
The Fig. 8 represent a surface recorded after the impact event, with a high precision of the surface reconstruction.

Fig. 8 Image 3D of the surface of the composite part recorded by the digital microscope after the impact test.

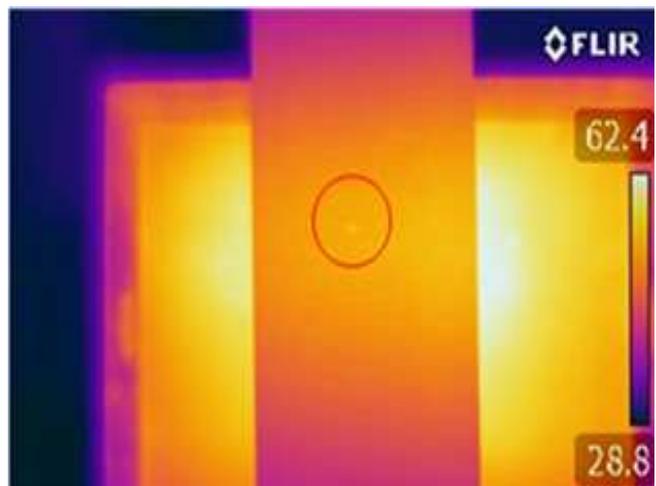
Fig. 9, show an increase in temperature, indicating the presence of defect which is probably a delamination between the folds. In addition, the increasing of the excitation time amplifies the response in the surface of the specimen. Indeed, the central zone reaches saturation for 42s, while the undamaged zone heat more slowly Fig. 10.

Fig. 9 Thermogram in transmission mode.

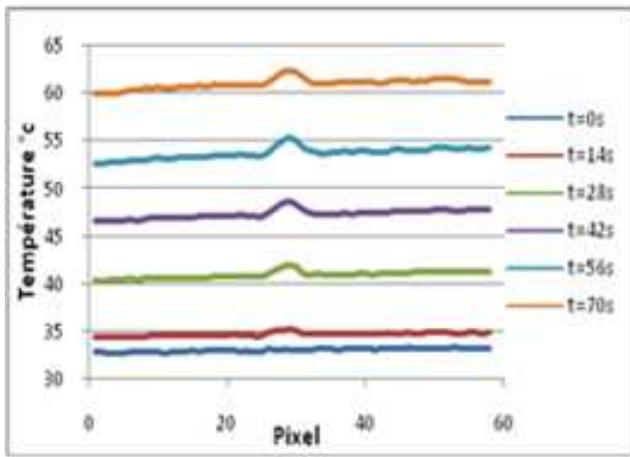
Fig. 10 Diagram representing the thermal evolution of impact as a function of time.

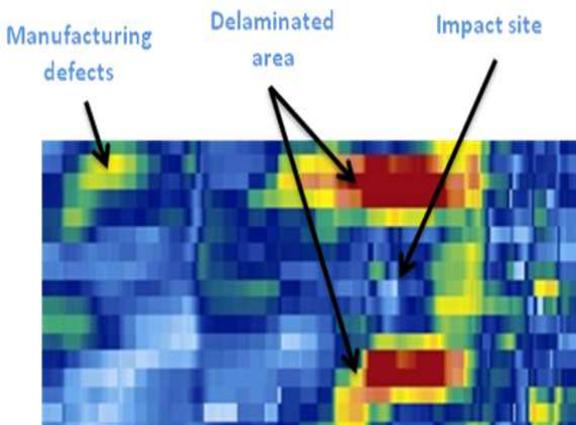
Then, the ultrasonic technique is applied locally in the damaged area for a finer analysis. A manual scanning is performed, for the purpose of obtaining cartography of the damaged area shown above in the Fig. 11. C-Scan cartography provides an aerial view of the controlled area. Indeed, this technique shows the impact damage throughout the specimen, and it allows us to measure the size of the damaged area.

Fig. 11 C-Scan cartography.

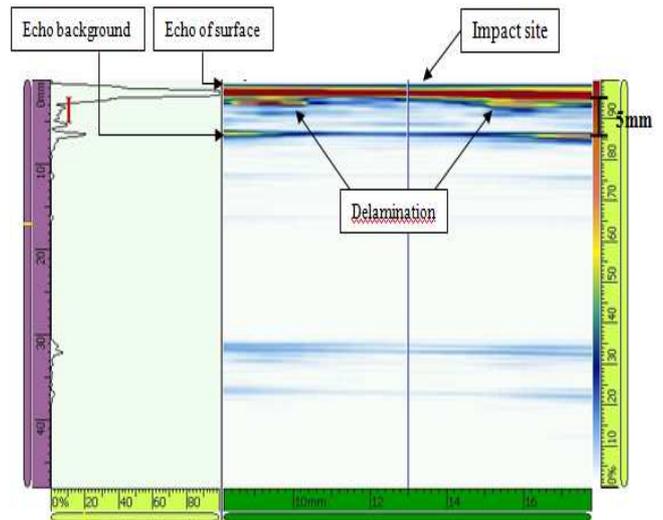
Fig. 12 represent the S-scans, which indicate the depth damage after the impact and allows us to give information about the thickness of the part (we extracted 5mm in the thickness which is in agreement with the real measurement of the piece). A very strong attenuation of the ultrasonic beam is observed, which is resulting from the anisotropy of the material and its structure (the orientation of the fibers, the stacking of the layers). In addition, it can be seen that the amplitude of the surface echo decreases in the impacted area (the thickness of the surface echo in the contact zone between the impactor and the part is small compared to the rest of the echo). There is also the appearance of the detachments between the folds in other words delamination, which is characterized by a conical shape (the origin of this cone is at the contact region between the impactor and the specimen). As can be seen, a discontinuity of the echoes under the damaged place (impact site). Indeed, these results are due to the impactor, which deformed the surface (concave shape). This deformation caused the diffusion of

the ultrasonic beam which explains the discontinuity of the echoes.

Fig. 12 A&S-Scan cartography of the damaged area.

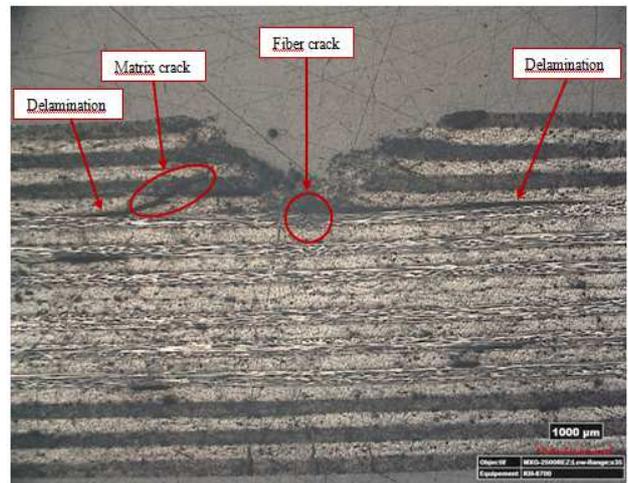
After the NDT controls, the specimen is examined under scanning, digital microscopy to investigate their microstructure, the interface and also the failure mechanisms. A conical shape in the thickness direction in the upper folds is observed (Fig. 13).

Generally, the observations revealed macro-cracks in the material, located in the conical zone observed previously. So, three kinds of internal damage were observed: fiber breakage, matrix cracking and delamination.

Fig. 13 Metallography photograph shows damage produced after the impact event at the impacted area.

Other defects are present in the specimen shown in the Fig. 13, they can be interpreted as porosity (manufacturing defect).

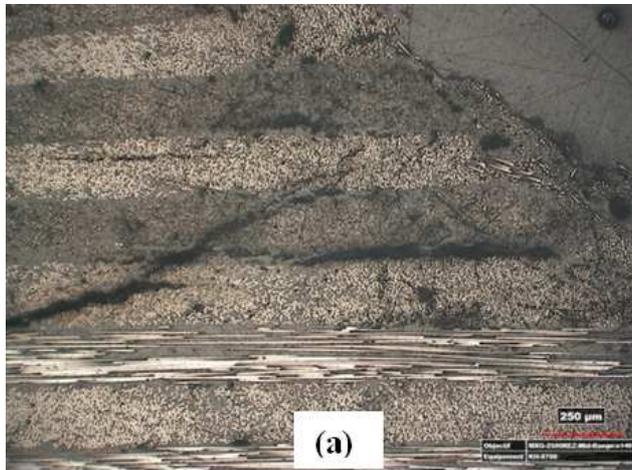
The first type of mechanism observed is matrix cracks. This type of crack is systematically linked to interface cracks (fiber / matrix decoheres) or to initial manufacturing defects. These cracks are due to transverse shear and appear in the first folds at some distance from the impacted area (Fig. 14(a)). They are inclined at 45° and propagate in the direction of the fibers (Fig. 13).

Fig. 14 Scanning electron micrographs showing (a) matrix cracking, (b) delamination between the layers and (c) cracking of the fibers.

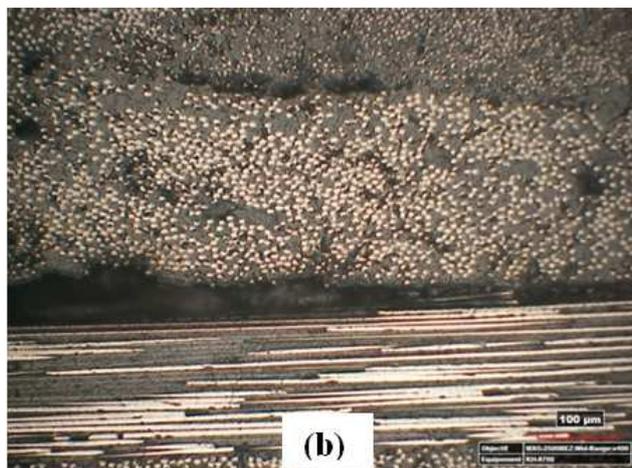
These various cracks will then cause delamination initiations at the upper and lower interfaces of the fold concerned (Fig. 13 & Fig. 14(b)).

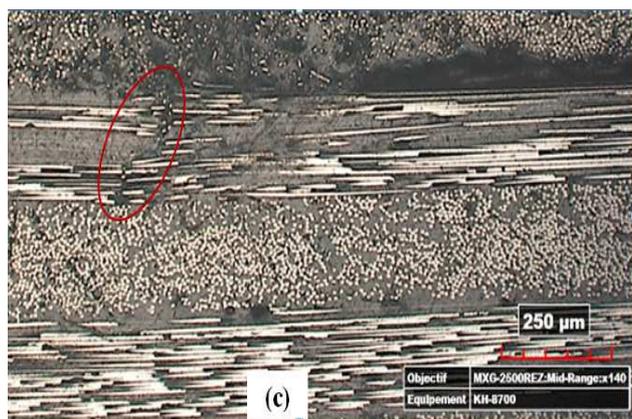
Finally, after matrix cracking and delamination appears the rupture of the fibers (Fig. 14(c)). They are located under the impactor in a region where matrix cracking and delamination are observed (Fig. 13).
