Assessment of Vulnerable Buildings Due to Earthquake Loading Using Rapid Visual Screening Smartphone Application

Abstract— Examination of vulnerability level of buildings to earthquakes is divided into two types, the quick checks (Rapid Visual Screening, RVS) and a thorough examination. On thorough examination, it involves specialists of the field of building structures and other related fields, takes longer and is also cost much more expensive. While a quick check, it does not involve many specialists in a particular area, does not require a long time and are relatively inexpensive. This study builds an assessment of the vulnerability of buildings quickly adapted from FEMA 154 to the conditions and rules that applied in Indonesia using a smartphone application. A Global Positioning System (GPS) technology is used to mark the location of the data of the examination. The smartphone application called RViSITS is used to simplify and speed up the examination process and sent via the internet, and the server as a gathering and processing data. Furthermore, from these data do building vulnerability mapping and disaster-affected areas, which can then be accessed by the public, governmen

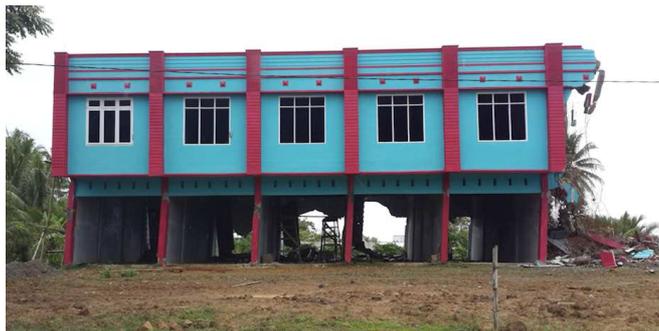
Fig. 1. Collapse of the Building in Aceh due to Earthquake

Earthquake is one of the disasters, which has caused much damage to the society, and it has been a threat to people for years [1]–[5]. There are numbers of lost, deaths and injuries as a result of an earthquake as shown in Fig. 1. The losses due to an earthquake event is directly related to the vulnerability of buildings and the awareness to provide first aid for people after the earthquake occur [6]. In many places, especially in Indonesia, many buildings were not designed according to the latest building and seismic code. In addition, there are no data related to the vulnerability of each building to the earthquake which resulting damage to numbers of buildings during the earthquake. In fact, the seismic safety of the building is crucial to reduce losses due to the earthquake.

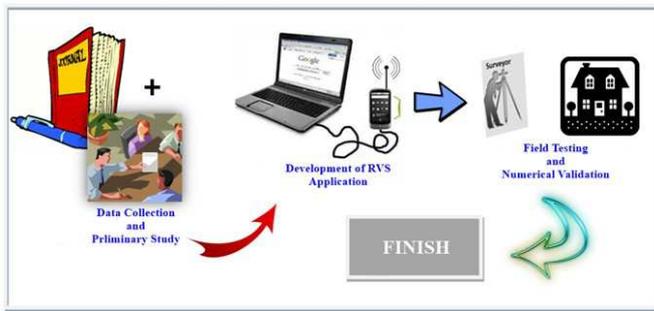
Fig 3. Illustration of Research Methodology

The main purpose of this study is to establish the rapid visual screening smartphone application, which can be used to identifying potentially hazardous buildings due to an earthquake. The research is divided into three main activities. The illustration of research methodology can be seen in Fig. 3. The first step of this research was focused on collecting data and performed a preliminary study related to the assessment of the potentially earthquake-affected building. The preliminary study including sorting references and regulations and also performed score factor analysis on RVS form based on FEMA 154. The second step is developing the rapid visual screening smartphone application RViSITS. This application is developed with Android platform and based on the FEMA 154. At the end of this research, a series of field-testing was performed to verify the RViSITS application. RViSITS application examined four buildings and verified by a numerical analysis using SAP 2000 to find out the performance of the four buildings based on Indonesian seismic design regulation of SNI 1726:2012. The result of each analysis was compared to check the accuracy of the RViSITS performance.

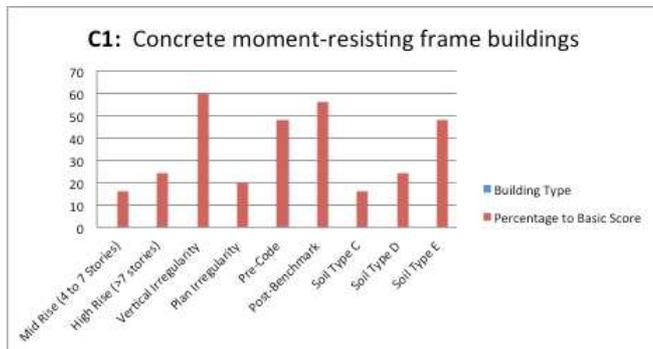
Fig 4. Comparison of Modifier to Basic scores of C1

The comparison between the component of the M scores can be analyzed to see which component of the scores are more influence comparing with others. Fig. 4 is an example of the structural type of concrete moment resisting frame

buildings (C1). As shown in Fig. 4, the components of M scores that must be noticed are the vertical irregularity and post-benchmark code which the both scores has a high score. It means the component will have an influence more on the final score (S Score).

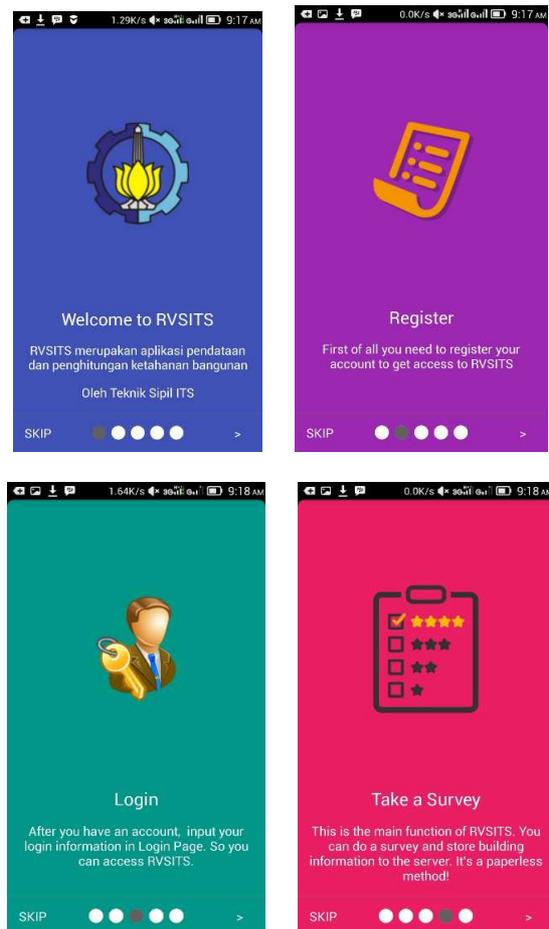
Fig. 5. Welcome Screen of RViSITS App

This android program is named RViSITS, and this application is an update of previous versions. The new version of the application has been more users friendly so that it can be used more efficiently. After installing the application on the android phone, it will appear the home page as can be seen in Fig. 5. By sliding the screen on the home page will be presented steps of use of this application.

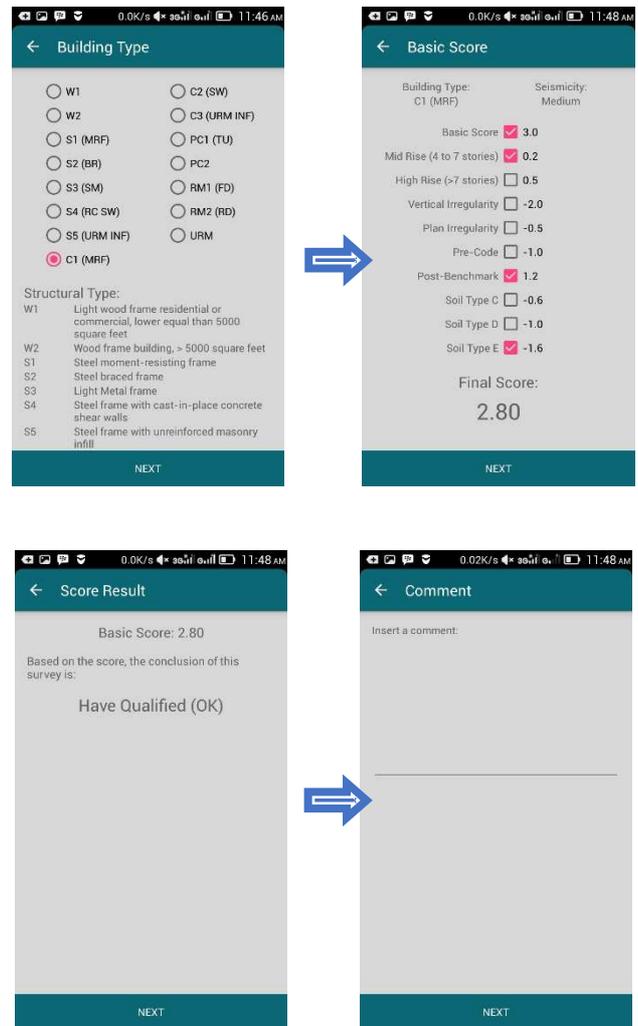
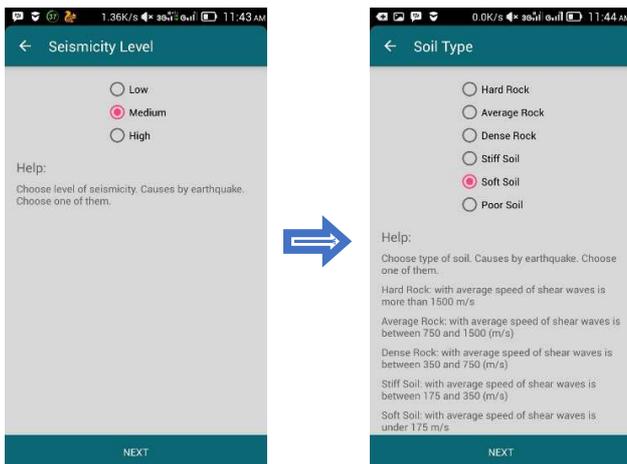
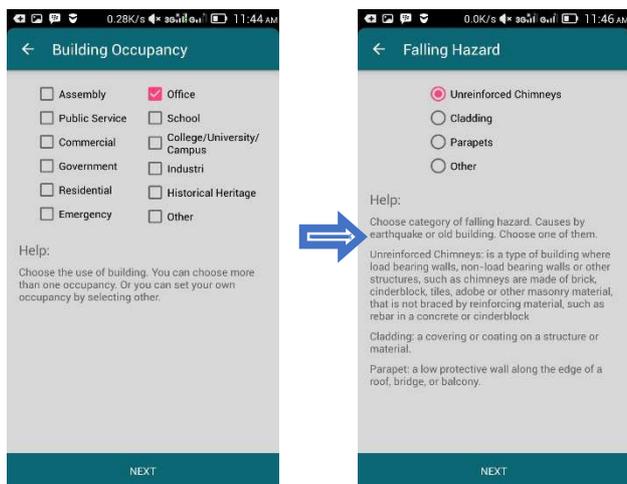
Fig. 6. Step by Step Form Filling on RViSITS App.

The survey started by fulfilling the building data, which include building name, address, built date, total floor area, and picture. The location of the building will be integrated with a global positioning system (GPS). After complete this step, the survey continued with fill the form one by one. Fig. 6 shows step by step completing the survey with RViSITS app. At the last stage, the primary score must be filled on, and the score will be appearing on the screen. The surveyor also can include their comment at the last screen.

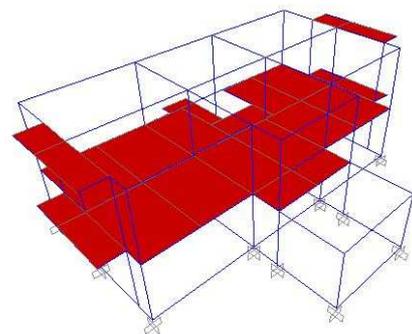
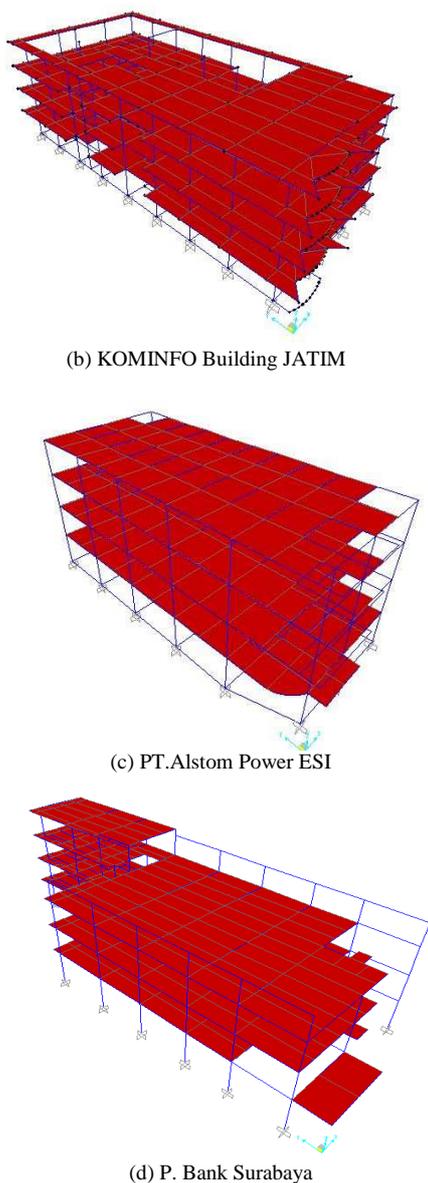
(a) BPBD Building JATIM

Fig. 7. Numerical Modelling Using SAP 2000 for 4 case studies

The numerical analyses of the four buildings were performed by using SAP 2000. This program was used to analyze whether the structure meets the requirements of Indonesian codes [11, 12]. The Indonesian codes used in this research are SNI 1726:2012, which is a standard of earthquake resistance planning procedures for building and non-building structures, and SNI 2847:2013, which is about concrete structural requirements for buildings. Fig. 7 presents the model of four buildings, which used SAP2000.
