Liquefaction Analysis of Beach Protection Structure: Numerical Simulations

Keywords— liquefaction; abrasion protection structure; numerical analysis.

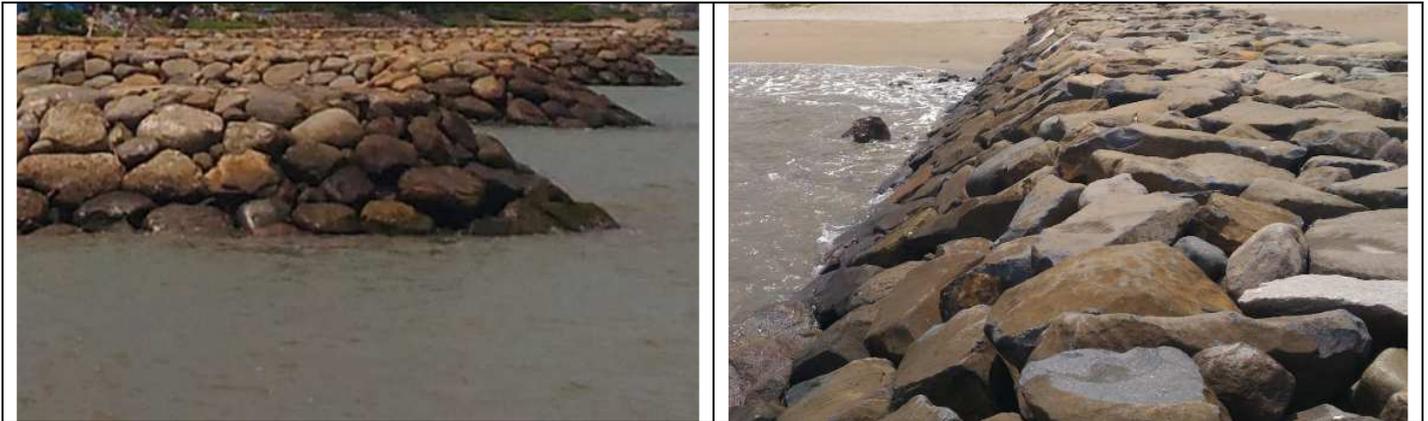
Fig 3. Typical groin in West Sumatra

Typical groin structure to be modeled in numerical simulations is adopted from the existing groins which have been made along the coast of Padang (Fig 3). The groins are made of mountain rock arrangement with a height dimension of about 5m, 5m of crest width and the side slope is 45

degrees. The other data to be used in the numerical analysis are 50 degrees for internal friction angle with a modulus of elasticity twice the ground sand.
