## Investigation of Pangkalan Floods: Possible Reasons and Future Directions

**Abstract**— Two flood events in Pangkalan, Lima Puluhan Kota Regency on 3 March and 29 December 2017 have triggered some questions whether a dam downstream the catchment is solely responsible, or they were caused by other factors. In fact, several other major floods have been recorded after dam commission in 1998. Yet, the catchment have undergone rapid land use conversion into commercial plantation such as palm and *Uncaria gambir* Roxb (*gambir*) since mid-1990's. To understand the flood, three contributing factors i.e. flood inundation by the dam and river tributaries, land use changes, and rainfall data were discussed and analysed, and some field works were conducted along the main river and flooded areas. Flood inundation was estimated using Digital Elevation Models (DEM) of 30 m in resolution and modeled using QGIS. Land use changes from year 1994 were analysed from Landsat and EVI (Enhanced Vegetation Index) time series. Rainfall data were collected and analysed using nearby station from year 1980. Flood inundation analysis showed that dam spillway at an elevation of 80 m is unlikely the main rea

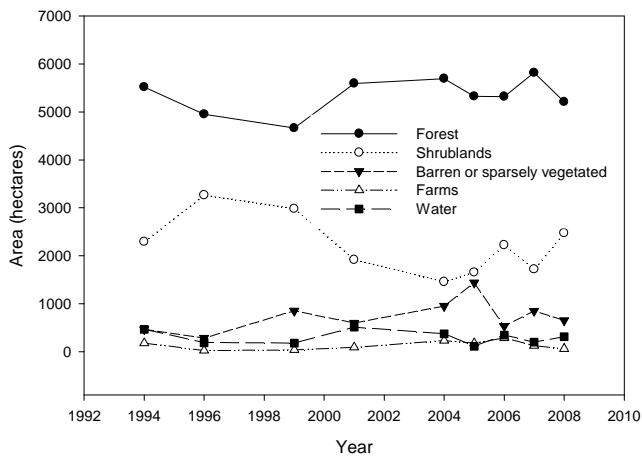
Fig. 10 Land use changes from 1994 to 2008 at Managing sub-catchment.

Paddy farms inhabit a small part of the catchment due to its hilly terrain and water scarcity in the upper part of the hills. Therefore, *Uncaria gambir* Roxb (locally known as *gambir*) is a popular commodity since it can live in hilly terrain and does not need irrigation. This plant is a shrub-like tree, with a height of 1-1.5 m, harvested by cutting its leaves and twigs. Due to increasing demands and stable price, more lands were converted into Gambir's farms at the individual scale. Landsat identified Gambir as shrub lands (Fig. 11). However, Landsat fails to distinguish between palm plantation and forest. Time series from 1994 to 2008 exhibited unusual trends in that total area of forest increased from 1999 to 2004 (Fig. 10). In the same period, Google

Earth showed that in this area, forest declined and converted into palm plantation.

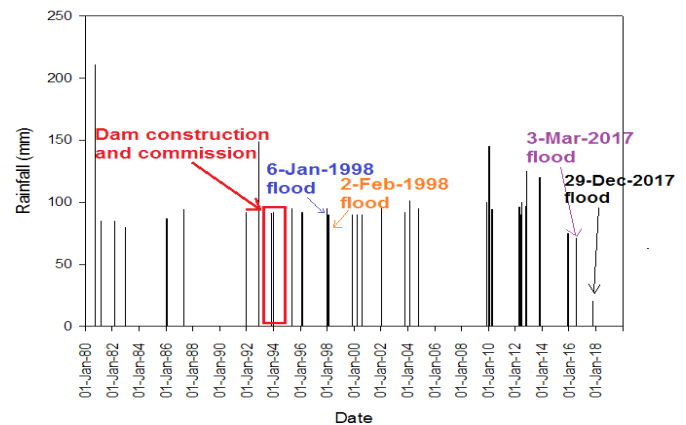
Fig. 12. Maximum Daily Rainfall at Tanjung Pati Station.

Rainfall data since 1980 reveals that maximum daily rainfall at Pangkalan reached 211 mm on 5<sup>th</sup> October 1980 (Fig. 12). The second highest recorded was 145 mm on 22<sup>nd</sup> January 2010. On the day of the flood on 3<sup>rd</sup> March 2017 daily rainfall reached 50 mm, but this has been preceded by rainfall on two consecutive days on the first and the second of March. However, due to unavailability of rainfall intensity, it was difficult to estimate hourly rainfall and duration.

Rainfall record exhibits some critical information on the occurrence of floods in Pangkalan. Before dam construction and commission from 1993 to 1996, a rainfall of twice higher than that of the 1998 rainfall that caused the first big flood after dam commissioning has been recorded in this area. Although the intensity is unknown, this magnitude is classified as very high and rare compared to the rest of West Sumatra [21]. No flood was reported this year. On the other hand, two high rainfall of 95 and 90 mm on 6<sup>th</sup> January and 2<sup>nd</sup> February, respectively, has resulted in floods on these days.

Likewise, in 2017 floods, two rainfall similar to that of the 1998 flood also caused floods but at a different scale. On 3<sup>rd</sup> March 2017, rainfall on three consecutive days on 1<sup>st</sup>, 2<sup>nd</sup>, and 3<sup>rd</sup> of March with daily rainfall of 19, 2.2, and 50.3 mm, respectively, caused a flood in sub-catchments 1 and 2. On 29<sup>th</sup> December 2017, the flood covered mostly in sub-catchment 1 with sub-catchment 2 nearly unaffected. On this date, the recorded rainfall was 19.2 mm or less than one-third of the 3<sup>rd</sup> March event. Although this rain is much less, the topographic conditions of the area and the river morphology are the main reasons for the flood. Sub-catchment 1 is steeper with fan-like catchment. Steep and
