Covered Conductor Burn-Down Phenomena in Indonesia without Protection Relay Operation

Abstract— All Aluminium Alloy Conductor-Shielded (AAAC-S) which is covered conductor is widely used as the temporary solution to mitigate the earth fault problem during application of bare conductor in Indonesia distribution system. However, the burn-down phenomenon of AAAC-S is often found in some cases, and the protection schemes that have been installed on the distribution line is unable to detect any fault during the phenomenon. Due to no tripping order from protection relay, this phenomenon will lead some part of the conductor to remain hanging in the air and still in energized condition. This condition may cause a potential hazard to the surrounding environment. Therefore, this study was performed to determine the cause of AAAC-S burn-down, and the reason of protective equipment cannot work properly. Field investigation, modeling and simulation, and laboratory testing have been performed in this study to represent the condition in the field. The results show that the burn-down phenomenon of AAAC-S occurred due to many sequences of events. It started with insulation material breakdown that c

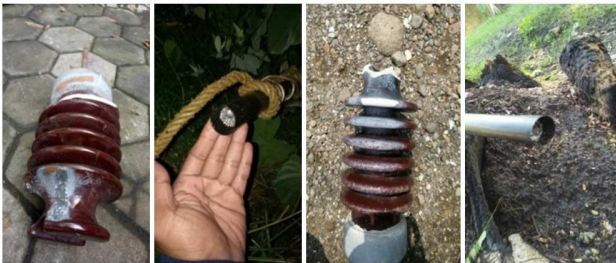
A survey in the distribution network that uses AAAC-S (size 70mm^2 to 240mm^2) has been performed to find out the further information of the AAAC-S burn-down cases. The survey results show that 34% of the distribution feeders have experienced the AAAC-S burn-down and more than 60% of the burn-down cases occurred near the isolators. The other 40% of burn-down cases happened in the middle of span caused by the trees that hit the AAAC-S. For the burn-down case near the isolator, the conditions is shown in Fig. 1, which shows a burning trace on the insulator and a neat cross-section cut of AAAC-S with a melting trace.

Fig. 1 AAAC-S burn-down and burning a trace on the insulator

Based on the survey data that are given in Fig. 1, a presumption appears that the AAAC-S were broken due to the heating condition that exceeds the melting point of aluminum (about 600°C) that possibly occurred due to the arcing process on the AAAC-S. On the other hand, it was found that the protection relay does not work when the AAAC-S burn-down. To ensure the cause of the AAAC-S burn-down and undetected by the protection relay, the modeling and testing steps have been performed as given in the next section.

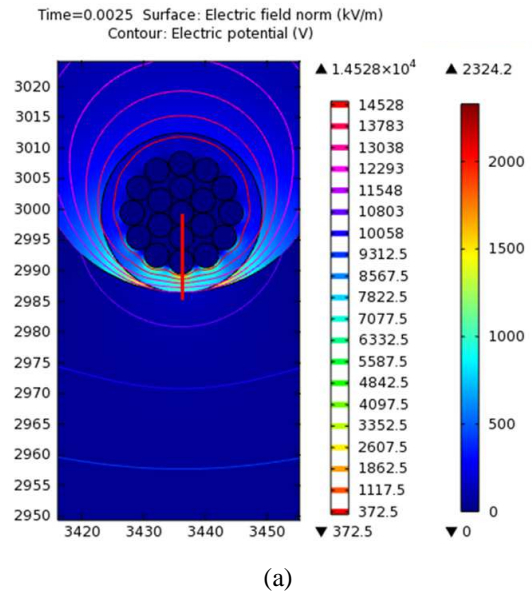
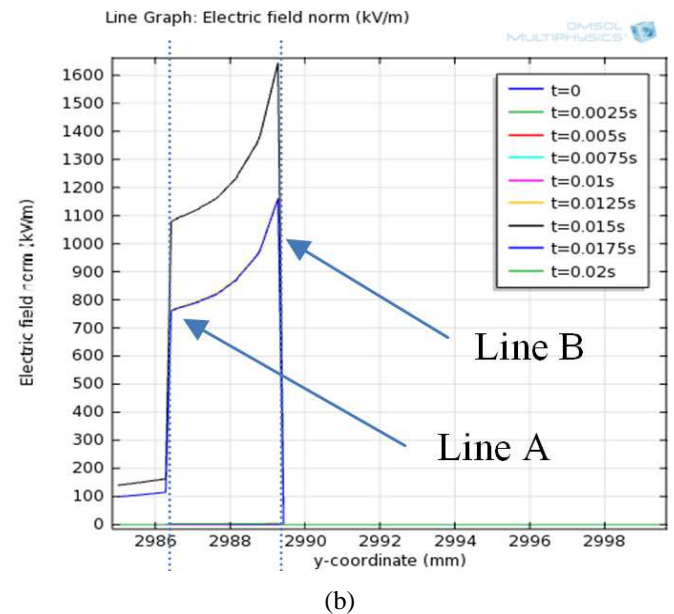
The modeling process has been performed using finite element analysis software. The process was started by making a geometric model of an AAAC-S cross-section that located above the ceramic insulator as given in Fig. 2(a). In this condition, an operating voltage of 20kV_{rms} addressed in the AAAC conductors. Then, the voltage value was varied

according to the sinusoidal condition by taking a sampling time every 2.5ms during a full cycle. The simulation then continued by applying the governing equation, meshing, and post-processing of the result as given in Fig. 2(b). The vertical line in Fig. 2(a) represents the horizontal axis of Fig. 2(b). “Line A” is the boundary plane between XLPE and the insulator, while “Line B” represents the boundary plane between AAAC and XLPE.

Fig. 2 Voltage stress simulation of the cross-section area of AAAC-S

Fig. 2(b). Shows the voltage stress that occurs for each simulation time by using a sinusoidal voltage wave with a frequency of 50Hz and an amplitude of 16.329kV (representing a phase-neutral peak voltage value on a 20kV distribution network). Time $t = 0$ showed the voltage stress value when the voltage condition had a value of 0, time $t = 0.0025\text{s}$ shows the voltage stress value when the voltage reaches the peak value, and so on for the other t values.

According to the Fig. 2(b), it can be seen that the maximum voltage stress value occurs on XLPE material especially at “Line B” (with a maximum value of 1600kV/m). Then, the voltage stress value reduced to reach a value of 1100kV/m at “Line A.” Based on the result of voltage stress value, the partial discharge will occur at “Line A” and “Line B” with the maximum partial discharge will occur at “Line B.” In addition to finite element simulation, a laboratory test was also performed to validate the appearance of partial discharges in AAAC-S. This test was performed by providing an AC voltage of 30kV/50Hz on the AAAC-S conductor and then recorded by the corona camera, which the result is given in Fig. 3.

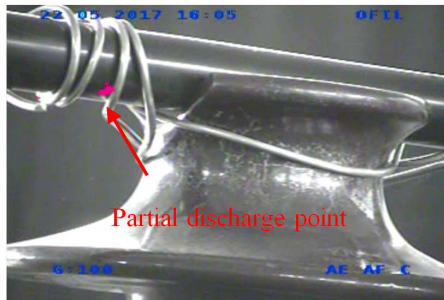
Fig. 3 Partial discharge appear on the lower side of AAAC-S

Fig. 3. shows that the partial discharges appear on the lower side of the AAAC-S (as given by the magenta color). These results indicate conformity to the simulation results that obtained in Fig. 2. Based on [1]-[5], the occurrence of partial discharges for long periods will lead the breakdown process of insulation material. Also, a breakdown in the insulating material may also occur due to friction between AAAC-S and its binding material when the AAAC-S swung because of mechanical force. This breakdown is marked by the appearance of the pinhole on AAAC-S. The pinhole is a small hole that occurs on the XLPE insulation that makes the AAAC conductor exposed directly into the air.

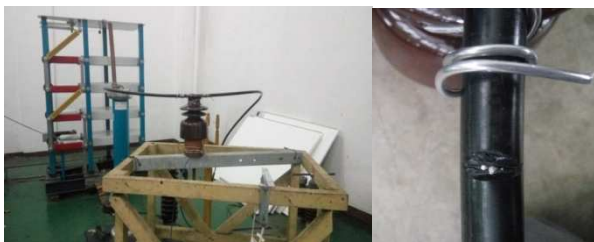
To understand the effect of pinhole when lightning struck AAAC-S, the voltage impulse test has been performed. The test scheme is given in Fig. 4. The pinhole that tested on this scheme is an artificial pinhole that obtained by an incision on XLPE material so that the AAAC material is exposed into the air. The artificial pinhole is used to speed up the testing process because the natural pinhole will be formed for an extended period.

Fig. 4 Voltage impulse testing

Based on the test results, when lightning impulses stroke the AAAC-S and the voltage that generated by the lightning

impulse exceeded the basic insulation level (BIL) of the insulator, then an arc current will arise from the pinhole towards the grounding part of the insulator. It happened because the closest path that connects the conductor to the ground is only from the pinhole point to the insulator ground, while the XLPE material [5] isolates the other paths.

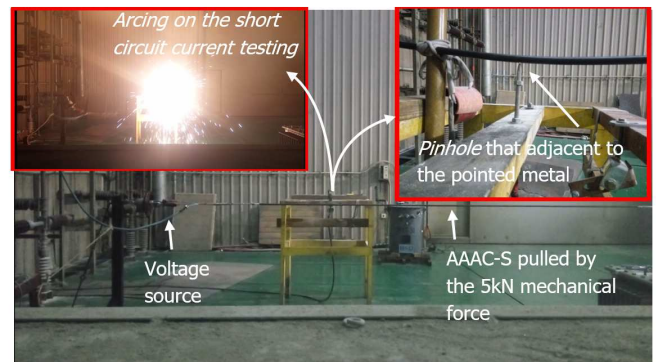
Fig. 5 Short circuit current testing

Fig. 5 explains that the mechanical force of 5kN pulls the conductor, and then the other endpoint of the conductor is connected to a voltage source. In the middle span of the conductor, an artificial pinhole placed adjacent to a pointed metal material. This fine metal material is connected to the ground, and it serves to trigger the occurrence of arc from the pinhole when the system voltage exceeded the breakdown voltage of the air (between the pinhole and the pointed metal). When the arc occurred, the current from the system will flow from the pinhole to the pointed metal and create a phase to a ground fault condition, with the voltage and current waveform as given in Fig. 6.

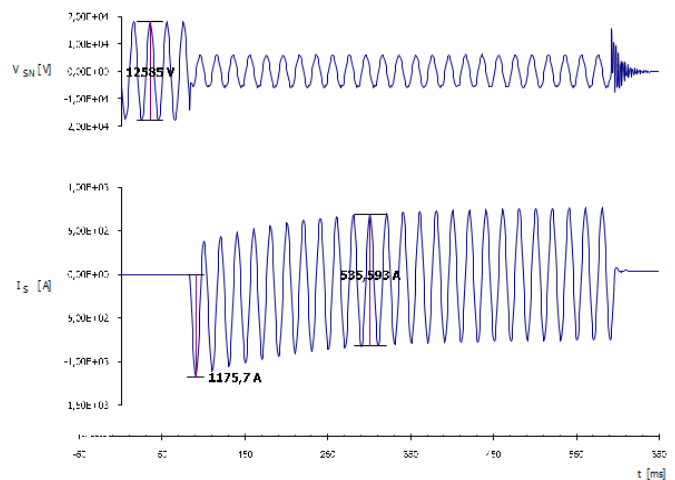
Fig. 6 Current and voltage waveform when short circuit testing

Fig. 6 shows that the short circuit current value is about 535A peak to peak and short-circuits voltage is about 2970Vrms, with the short circuit duration of 500ms. Besides the electrical parameters such as voltage and current, AAAC-S is also pulled by the mechanical tension of 5kN during the test. The tension value represents the real mechanical force that applied on the AAAC-S in the field, which is about 30% of the ultimate tensile strength owned by AAAC-S. In this case, the AAAC-S that used in the test is 70mm² with the ultimate tensile strength of 18kN. Measurement of AAAC-S tension during the test is carried out by a load cell.

During short circuit test, the result shows that AAAC-S is burn-down after two times short-circuit current injection. One short-circuits injection yields 0.56MJ of energy so that the accumulated energy supplied through the pinhole during two times short-circuits injections is about 1.13MJ. Thus, it can be found that the AAAC-S size of 70mm² will burn-down with the energy of 1.13MJ for the tensile force of 5kN. This energy is assumed as minimum energy that capable to break the 70mm² AAAC-S. This minimum energy is then called as critical energy, and it will be used as basic data to determine the critical duration required to break the AAAC-S. As the result of the burn-down on the short-circuit test, the cross-sectional shape of AAAC-S is given in Fig. 7.

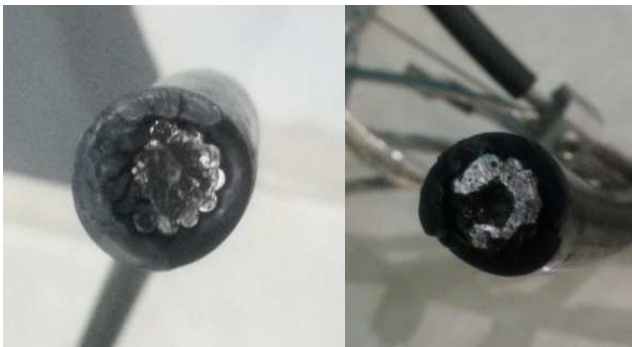
Fig. 7 AAAC-S cross section after the short circuit test

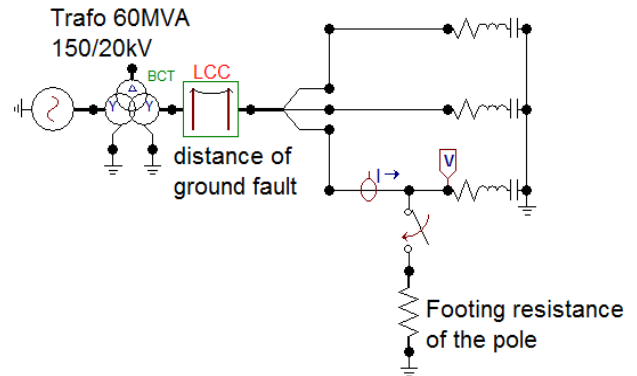
the transformer and the longest distance is about 19.35km. To observe the performance of the protection relay that used to handle the phase to ground fault condition, then some simulations were performed. The simulation purpose is to find the effect of short circuit location, grounding resistance of the pole, and the size of AAAC-S. The simulation was performed using the transient program analysis with a model as given in Fig. 8.

Fig. 8 Short circuit model

After the simulated ground fault current was obtained, then the relay working time is calculated according to the previously mentioned GFR setting (TMS = 0.3 and $I_s = 200A$). Then, the critical time for AAAC-S to get burn-down was calculated by dividing the AAAC-S critical energy to the power occurring under the ground fault simulation. By using the calculation, the performance of protection relays can be obtained as shown in Fig. 9 to Fig. 12.

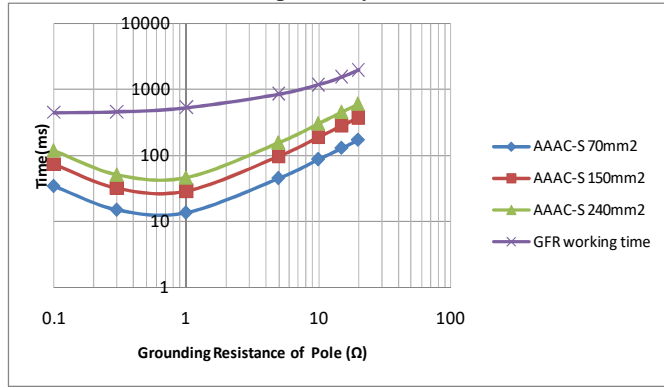
Fig. 9. shows the comparison of AAAC-S critical time and relay working time when the fault (short circuit via pinhole by lightning impulse) occurred 0.5km away from 150/20kV, 60MVA transformer. Under this condition, for each grounding resistance value, the relay will not be able to initiate the signal to trip the circuit breaker because the AAAC-S critical time is faster than the GFR working time. Therefore, AAAC-S will burn-down before the relay works.

Fig. 9 The comparison of the critical time of AAAC-S and the working time of GFR when the fault distance $s=0.5\text{km}$

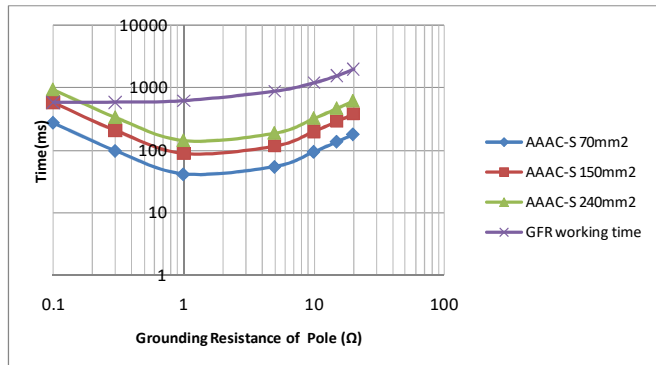
Fig. 10. shows the comparison of AAAC-S critical time and relay working time when the fault (short circuit via pinhole by lightning impulse) occurred 2km away from 150/20kV, 60MVA transformer. In this condition, the relay can only send a tripping signal to the circuit breaker for the 240mm² AAAC-S with the ground resistance less than 0.1 Ω , beyond that condition the relay will not work and AAAC-S will burn-down first.

Fig. 10 The comparison of the critical time of AAAC-S and the working time of GFR when the fault distance $s=2\text{km}$

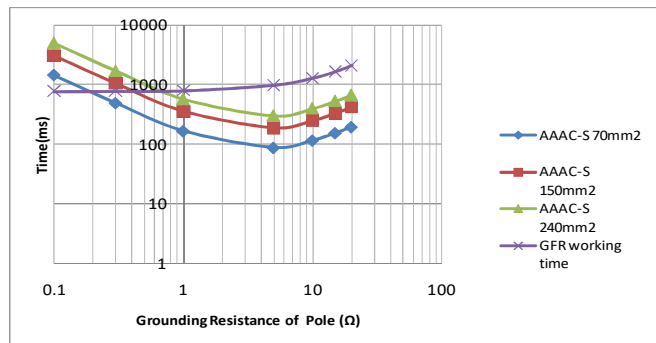
Fig. 11. shows the comparison of AAAC-S critical time and relay working time when the fault (short circuit via pinhole by lightning impulse) occurred 5km away from 150/20kV, 60MVA transformer. In this condition, the relay can send a tripping signal to the circuit breaker for AAAC-S with the size of 240mm², 150mm², and 70mm² when the ground resistance is about 0.1 Ω to the 0.5 Ω , about 0.1 Ω to the 0.3 Ω , and less than 0.1 Ω , respectively.

Fig. 11 The comparison of the critical time of AAAC-S and the working time of GFR when the fault distance $s=5\text{km}$

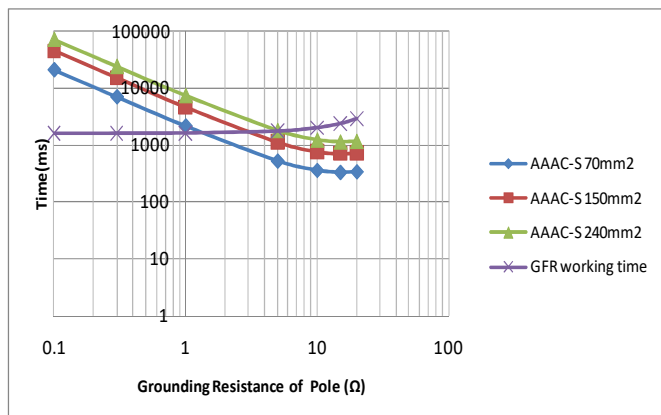
Fig. 12. shows the comparison of AAAC-S critical time and relay working time when the fault (short circuit via pinhole by lightning impulse) occurred 20km away from 150/20kV, 60MVA transformer. In this condition, the relay can send a tripping signal to the circuit breaker for AAAC-S with the size of 240mm², 150mm², and 70mm² when the

ground resistance is about 0.1Ω to the 5Ω , about 0.1Ω to the 3Ω , and less than 1Ω , respectively.

Fig. 12 The comparison of the critical time of AAAC-S and the working time of GFR when the fault distance $s=20\text{km}$
