## The Impact of Palm Oil Mill Wastewater on the Soil Properties of Paddy Fields

**Abstract**—A paddy field is a wetland area which always muddy and constantly flooded by irrigation. This land possesses impermeable layers, hence the irrigation water quality ought to be maintained, to prevent changes in its properties, as well as the paddy field features. Furthermore, wetland pollution by the palm oil mill wastewater PT BSS was experienced in June 2018, characterized by a lowered quality of water in the fields of Manggopoh Village, Agam District, West Sumatra. The purpose of this study, therefore, is to determine the effect of PT BSS palm oil mill wastewater on the quality of paddy fields, using a survey method to obtain samples through random sampling techniques. This research was conducted downstream, based on the direction of flow along the irrigation channel as well as on the uncontaminated fields upstream. Furthermore, a ring and ground drill was used in the collection process, and analysis for physical and chemical properties was conducted in the Soil laboratory of the faculty of Agriculture, Andalas University. Subsequently, the evaluation involved averaging the soil data, f

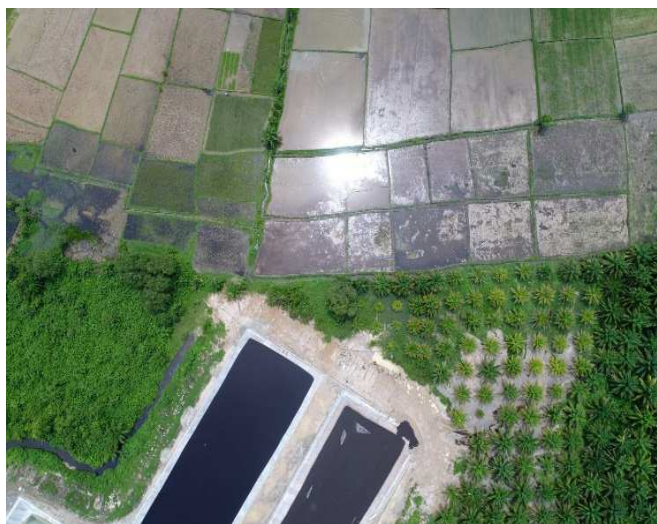
The research was conducted in the soil field in Manggopoh Village, Agam District, West Sumatra, Indonesia at June-August 2018 as in Figure 1. Materials and equipment used include mineral soil drill (auger Belgium), Munsell book, GPS, sampling ring, and plastic samples. Figure 1 below shows the paddy soil which is contaminated by palm oil wastewater.

Fig. 1 Paddy soil contaminated by palm oil mill wastewater in Manggopoh Village, Agam District

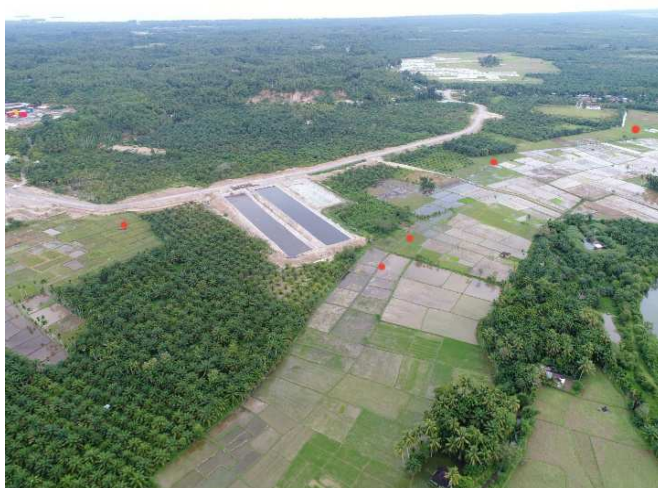
Fig.2 Location of rice field sampling contaminated by palm oil mill wastewater

The first sample was from the undamaged field upstream, while the second was from the contaminated rice field area, through land leveling from the closest point to the spill source, down to the furthest, in the direction of irrigation flow. The analysis of physical properties was performed on the uncontaminated unit, while chemical and biological evaluation was conducted on the supposed polluted filed.

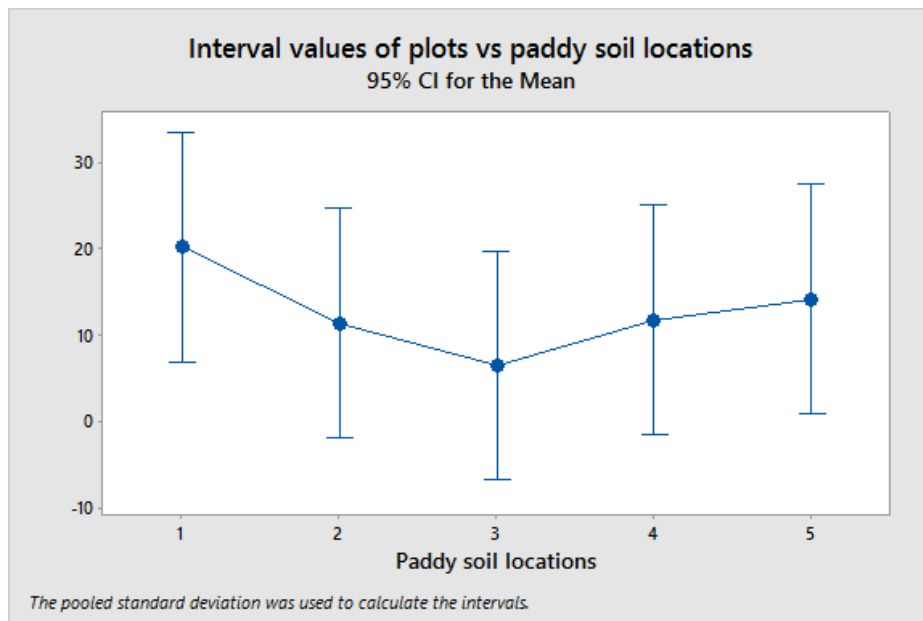
Fig. 3. The means value of soil properties at the research locations.

The results of the analysis did not indicate any significant differences and influence on the control and the contaminated locations were due to land saturation and water circulation. This was as a result of irrigation and rain. Figure 3 shows the highest value was recorded at location 1 (control), while the lowest mean was at location 3, which was within the 200 m range of the waste pond. The graph of means grouping using Fisher's test shows palm wastewater did not significantly affect soil properties. Figure 4. show group of average value from Fisher's test; the value of the nature of the high ground is more likely to be in the positive zone. Meaning the change in soil properties is not too full due to palm waste. Besides, several studies have reported its capacity to be used as organic fertilizer, and Figure 5 shows the effect on the growth of rice for 2 months.

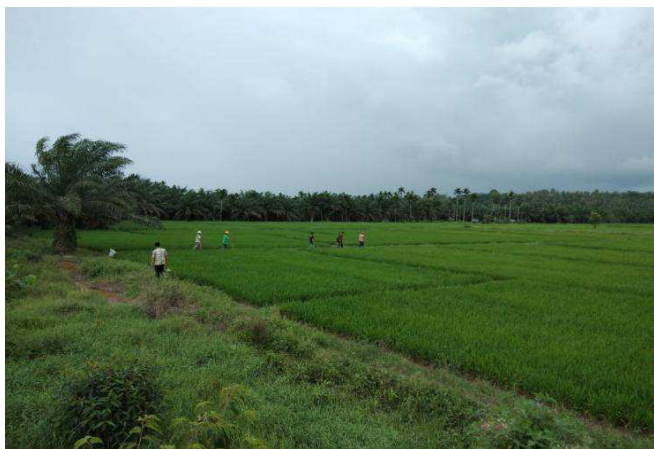
Fig. 5 Rice growth affected by wastewater spill palm in Manggopoh Village after 2 months.
